Impact behavior of a fully thermoplastic composite

# IMPACT BEHAVIOUR OF A FULLY THERMOPLASTIC COMPOSITE

S. Boria<sup>1</sup>, A. Scattina<sup>2</sup>, G. Belingardi<sup>2</sup>

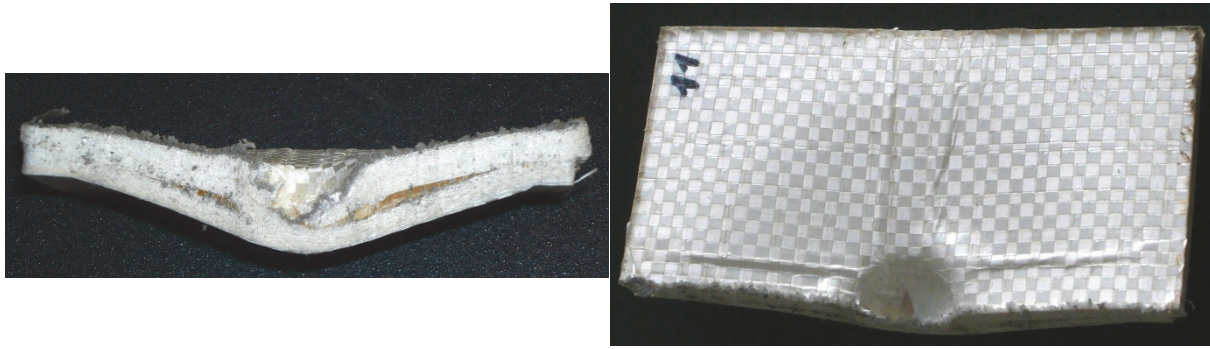
**Figure 10:** A section of a specimen after the drop dart test (test conditions: mass 7.3 kg, velocity 9.54 m/s, energy 332.1 J). The specimen was cut in its middle layer.

Other damage mechanisms can be observed in addition to the principal yarn sliding. The impact energy is spent mostly for delamination with the lighter impactor mass. Conversely, the impact energy is spent mostly for the fibers fracture around the impact point (in a zone with a radius of approximately 20 mm) for the heavier impactor mass. These behaviors depend on the difference between the inertia forces of the impactors with a mass of 7.3 and a mass of 67.3 kg. Despite the velocity relations, to stop the lightest impactor seems to be easier than to stop the heaviest one. The tests conducted at the higher velocity and with the lowest mass produce more dynamic vibrations than the opposite condition (lower velocity and the highest mass) (see the fluctuation of the force diagrams in figure 7a in comparison with the smoothness of the force curves in figure 7b). These high frequency vibrations overcome the shear forces by breaking the molecular chain of the polypropylene in each interface layer. This causes the delamination phenomenon. However, in the tests with the heaviest mass, a smaller amount of energy than in the test with the lightest mass is converted into vibrations. Consequently, the kinetic energy breaks the fibers with a resultant fiber damage. Another significant energy absorption mechanism may be due to different type of contact friction between the yarns: weft/warp yarn crossings, contacts between the plies and contact between the impactor and the first ply [49]. A cap formation can be observed in the rear skin of the specimens, as partially shown in Figure 10.

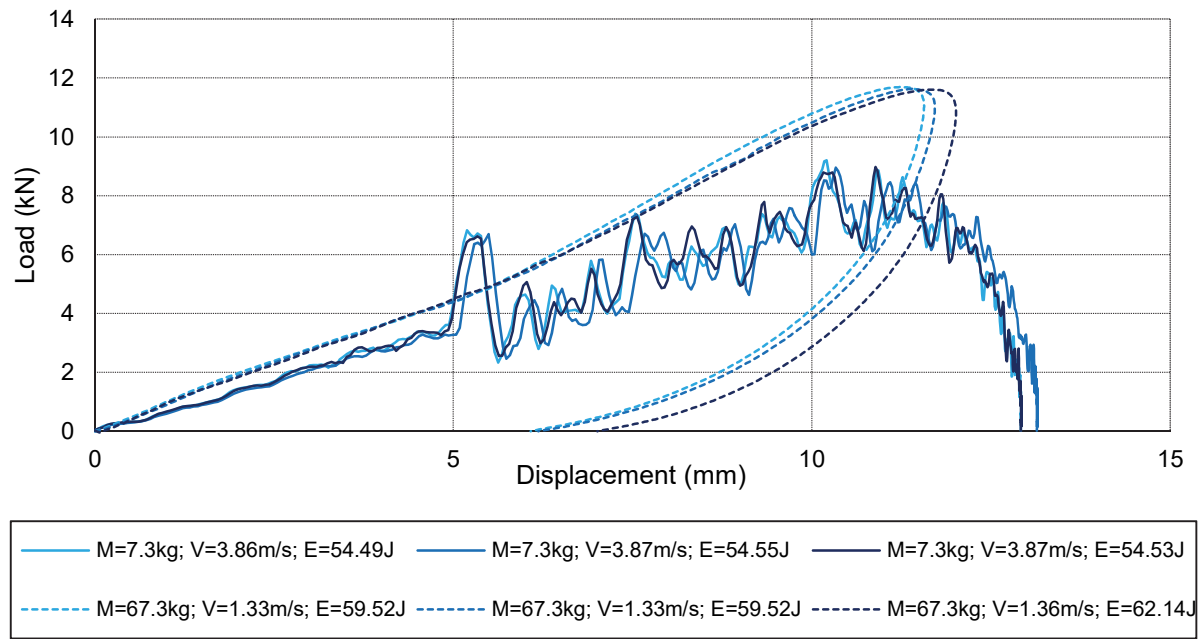
**Figure 11:** The contact force-displacement and the energy-displacement histories at constant impact energy  $\approx 57$  J.

A series of parameters were calculated from the experimental results in order to study the impact behavior of the material object of this work. In particular, the peak values of the contact force, the deflection of the specimen, the stiffness of the specimen, the energy absorbed by the specimen and the contact time were considered. The average values and the standard deviations of these parameters obtained in the experimental tests are summarized in Table 3. The stiffness was evaluated as the slope of the first linear part of the load-displacement curve. The obtained values are rather comparable considering the same impact conditions. The data are more scattered increasing the impact velocity, in particular considering the values of the load and of the deflection. Consequently, the stiffness values were also scattered at the highest velocities. The effect of the impact mass can be observed clearly from the diagrams of Figures 11 to 13 each of them is reporting the curves obtained from the tests at the same impact energy. The difference in terms of stiffness between the tests performed with the two mass values is much more prominent at the lowest impact energy. The trends of the first part of the force-displacement curves are more similar increasing the kinetic energy. In all cases, a higher stiffness was obtained with the highest mass.

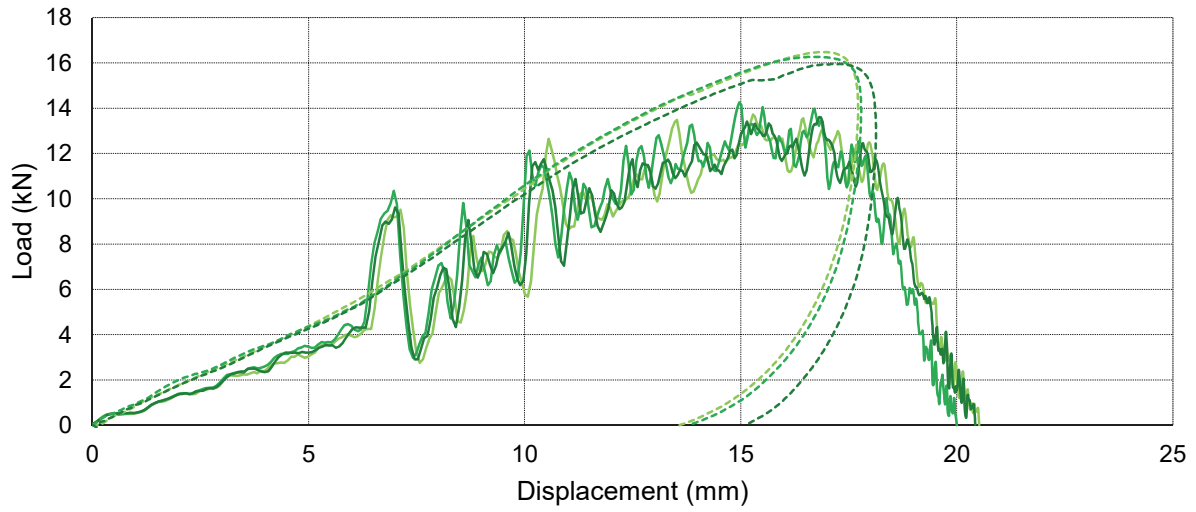
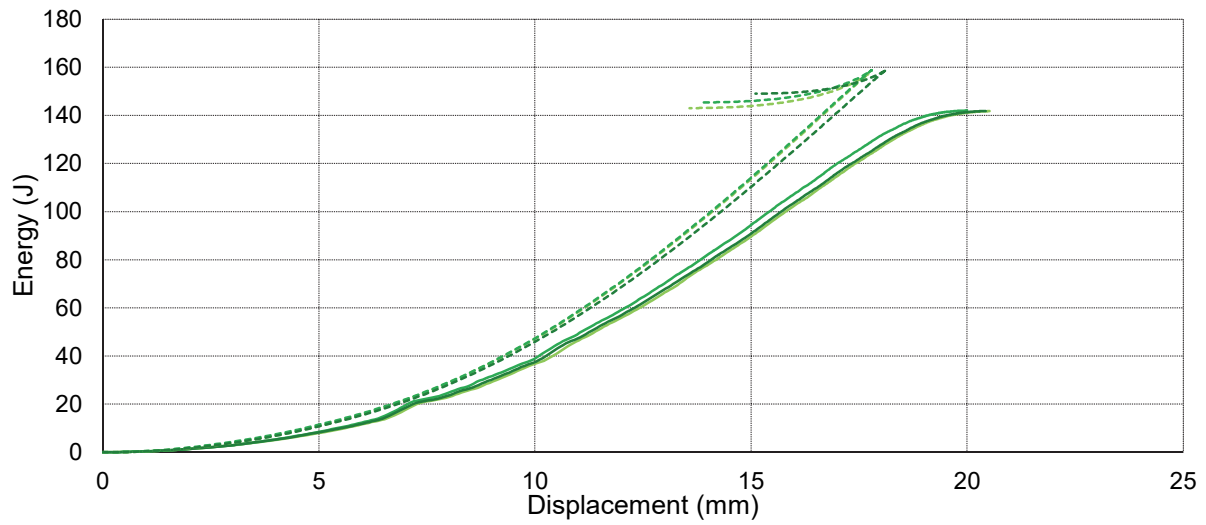
**Figure 12:** The contact force-displacement and the energy-displacement histories at constant impact energy  $\approx 144$  J.

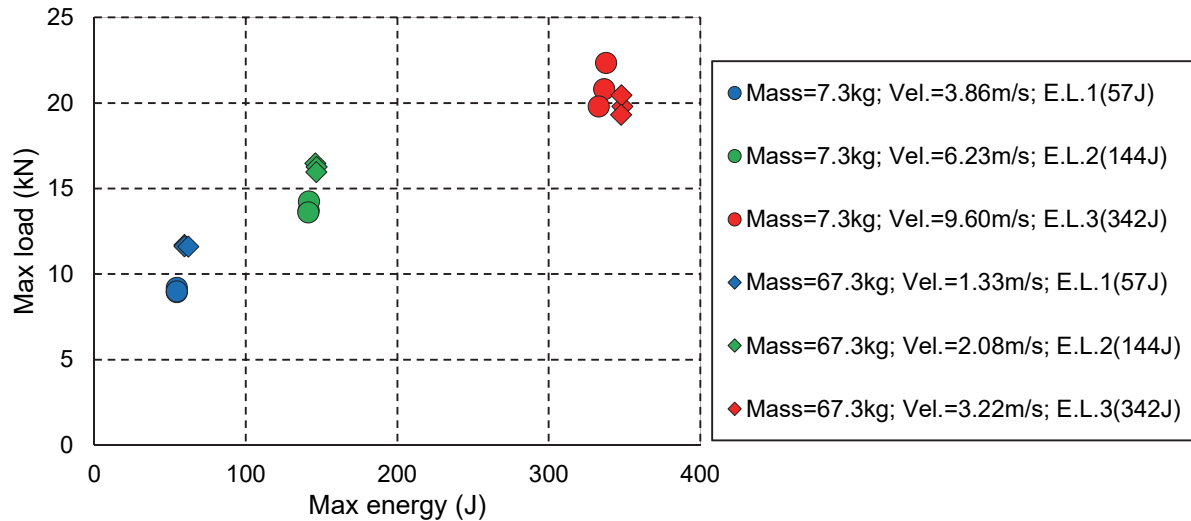
**Figure 14:** Trend of the maximum load as a function of the absorbed energy.

The difference of the contact times (Table 3) between the specimens impacted with the two different masses shows the energy transfer speeds. Transferring the energy in a shorter time implies an increase in the magnitude of the impulsive forces. More intense pulse forces cause more delamination and higher frequency vibrations than with slow impacts at the same impact energy level. A higher amount of the internal damages has also influence on the stiffness of the specimen as discussed in [54-55] and as evidenced in the following. Moreover, the maximum load tends to increase almost linearly with the growth of the absorbed energy as shown in Figure 14.

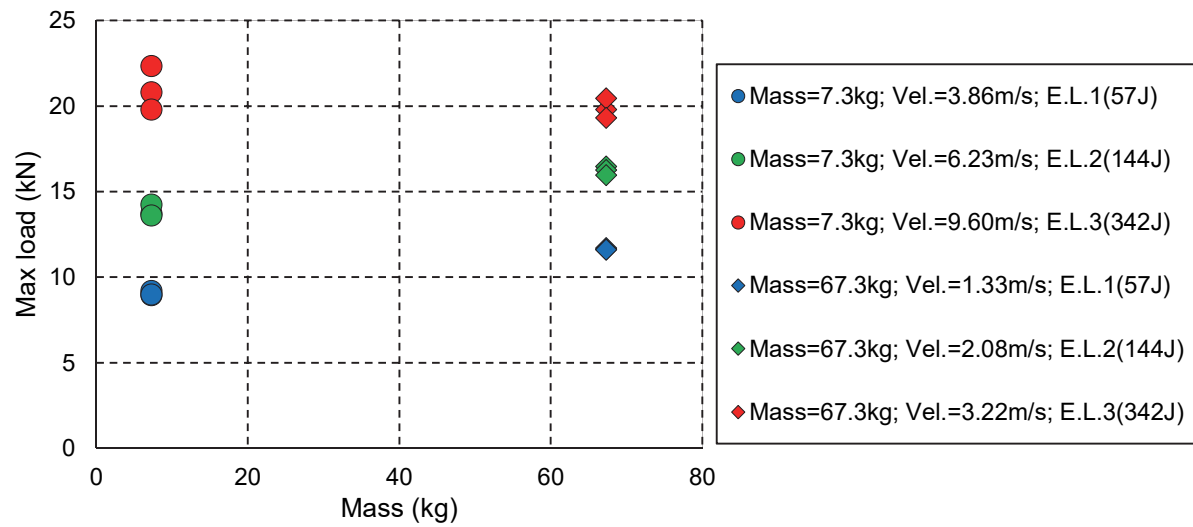
**Figure 15:** The effect of the impact mass on the maximum force, on the absorbed energy and on the stiffness.

The effects of the impact mass and of the impact velocity on the maximum load, on the absorbed energy and on the stiffness are shown in Figures 15 and 16. With an increment in the impact energy the increase of the maximum load due to a variation of the impactor mass is less evident. A change of trend was recorded for the highest energy level. An opposite behaviour was observed considering the velocity influence: with an increment in the impact velocity there was a decrease of the maximum load. This trend tends to reverse for the maximum energy level considered. The same analyses have been conducted for the absorbed energy and the stiffness varying both the mass and the velocity. The stiffness is influenced by the velocity and by the amount of the internal damage as discussed before and in concordance with has been illustrated in [47, 54-55]. Opposite behaviours were noted also in such cases. An increase of the absorbed energy and of the stiffness is evident increasing the mass, whereas higher velocity implies lower energies and stiffness.
