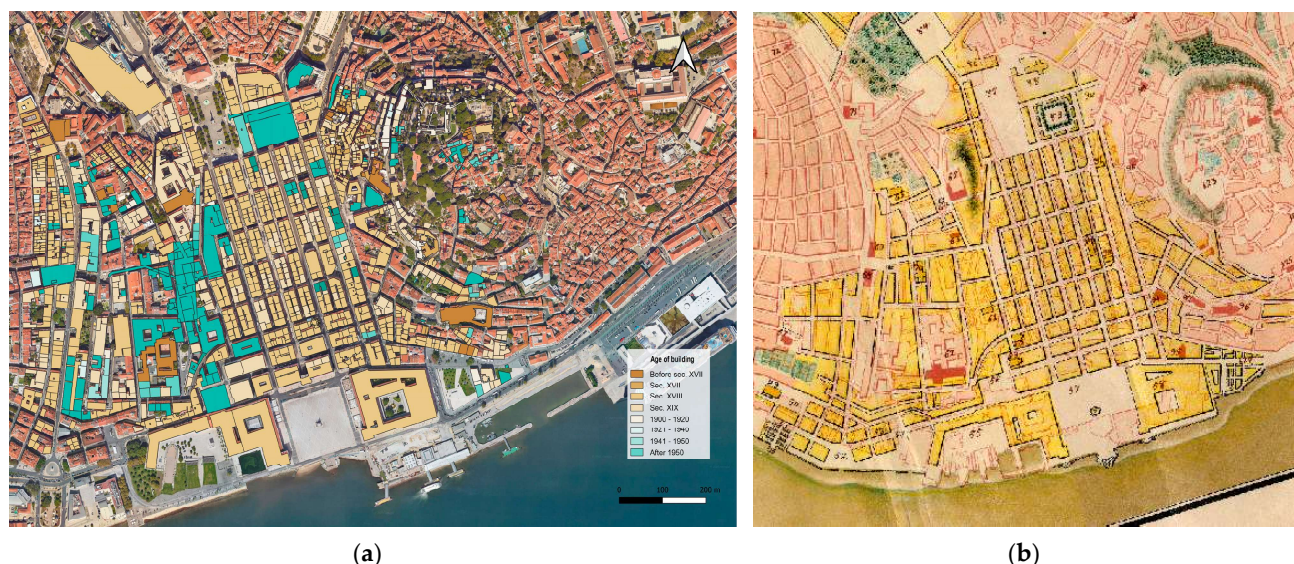
Figure 5. Current cartography of the Baixa of Lisbon with the dating of the individual buildings (a); historical cartography of the post-earthquake reconstruction of 1755 (b).

With the earthquake of 1 November 1755, most of the existing buildings in Lisbon were destroyed or severely damaged. At the time of the earthquake, Lisbon had a population of around 100,000 and an area of 350 hectares. After the earthquake, about 17,000 of the existing 20,000 houses were destroyed or made uninhabitable, as well as palaces, convents and churches, many of which were demolished and later rebuilt in other places due to the Baixa reconstruction plan. The new urban fabric planning was one of the strategies implemented by the then prime minister, the Marquis of Pombal.

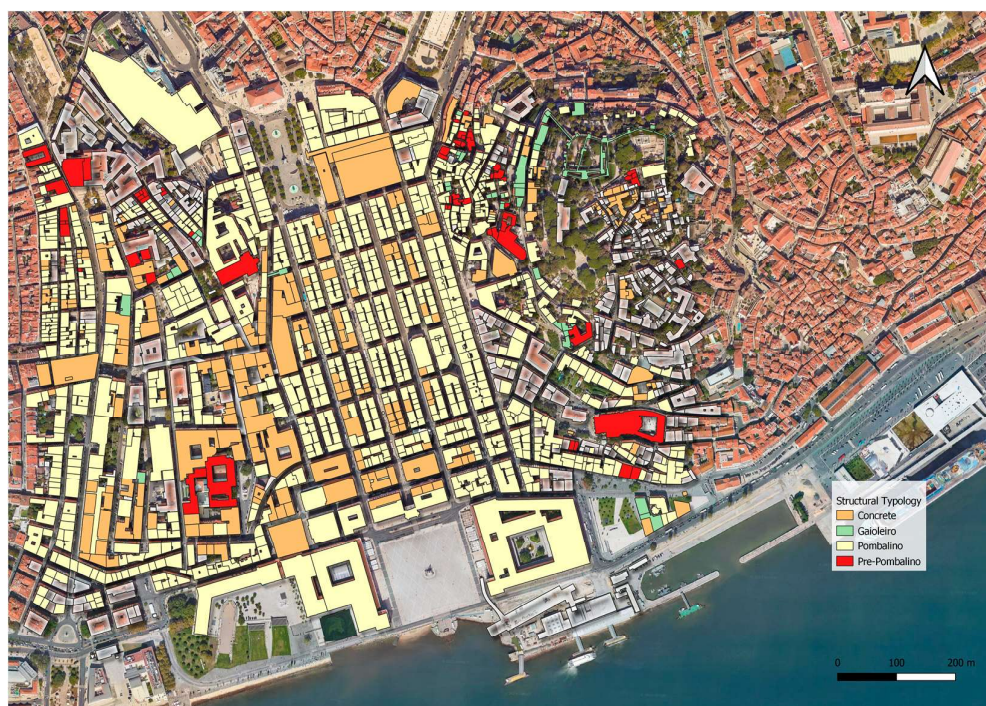
Figure 6. Construction typology of the buildings under study.

To establish a clear and concise evolution of building typologies, it can be said that masonry buildings constitute an important percentage of the building heritage of the city. Given the evolution over time of construction practices in masonry buildings, it is possible to detect variations in terms of architecture and construction types and structural design [41]. These differences determine significant variations in the seismic resistance of the different building types identified. Among the types of masonry buildings built after 1755, three phases can be distinguished: “Pombalino”, “Gaioleiro” and “Placa” buildings. The differentiation between the building types mentioned is based not only on the time of construction but essentially on the presence or less of wooden structural elements [42]. It is, therefore, possible to establish a subdivision in terms of building types based on their structural characteristics directly related to the time of construction and the construction technologies used (Figure 6).

- Buildings with “Pre-Pombalina” type masonry structure (before 1775)

Buildings that have withstood the great earthquake of 1755 in whole or in part and have been preserved over time to this day are considered an integral part of this category. This category includes buildings of historical interest, although many are in poor condition. This type of building consisted of two, three or at most four floors, generally with very low ceilings, a high density of walls and few openings to the outside. The floors of ground floors were generally made of limestone slabs. As for the floors of the upper floors, the use of wooden floors was more common. The vertical structures could be of three types: regular stone masonry (*cantaria*), ordinary masonry (*alvenaria*) or partitions (*tabique*). The differentiation is based on the type of material used in its construction and the related construction process.

- “Pombalino” Buildings—masonry structure type (1775–1880)

The pombaline plan is characterized by coherence, homogeneity and balance based on a layout of the road axes with a reticulated and regular structure and in the uniformity of the buildings designed, both in terms of elevations and in terms of internal subdivision [43].

The Gaiola (Cage) is made up of a set of timber frames with masonry infill, called “frontais”, connected at the corners by vertical bars that belong to the orthogonal walls. The connection between the orthogonal front walls through common vertical wooden bars and the timber floors forms a three-dimensional structure capable of resisting forces in any direction. In general, the space between the wooden bars of the front walls is filled with poor quality masonry and the surfaces are covered with finishing material, so the *gaiola* is generally not visible. Usually, the *gaiola* develops above the ground floor and in the internal walls.

The facades and walls between adjacent buildings are generally built with ordinary stone masonry, with some exceptions of better-quality masonry at the angles and in some columns and walls of the ground floor.

- “Gaioleiro” Buildings—masonry structure type (from 1880 to 1930)

The period between 1880 and 1930 was fundamentally characterized by a great expansion of the city, both for the creation of large urban areas, and for the increase in the height of the buildings: the name “Gaioleiro”, is intended to translate the simplification and the enormous changes in terms of structural and constructive systems on the Pombalino buildings, which included the increase in the height of the buildings which quickly reached five or six floors, accompanied by the distortion of the original cage, in which some elements of solidarity have simply disappeared of the “frontais” walls. The observed changes have given rise to another type of building characterized by the absence of structural and three-dimensional continuity.

- “Placa” Buildings—mixed masonry-reinforced concrete type (since 1930)

Around 1930, concrete appeared, used in full attics, progressively replacing wooden floors in kitchens and bathrooms, and protruding elements such as balconies up to the entire attics (Placa).

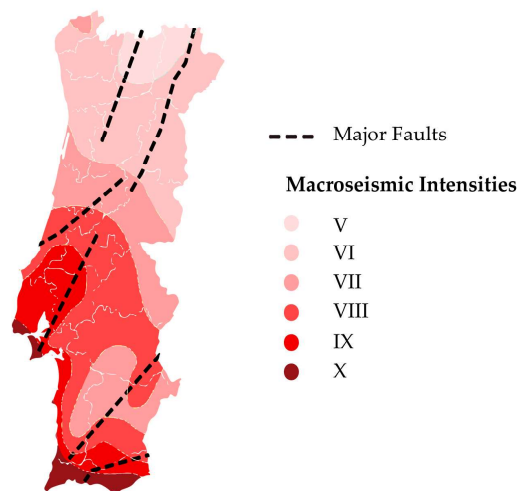
Figure 7. Map of macroseismic intensities and major faults in Portugal. Adapted from [45].

The Lisbon region and the Algarve region are located in the area with the highest seismic risk on the Portuguese continent; noteworthy are the regions of Tagus Lezíria and the Setúbal peninsula, located in the “Lower Tagus Valley Fault”, which also have a high seismic vulnerability. In addition, the coastal region of Alentejo has a medium-high impact index, along with a significant frequency of seismic events (Figure 7).

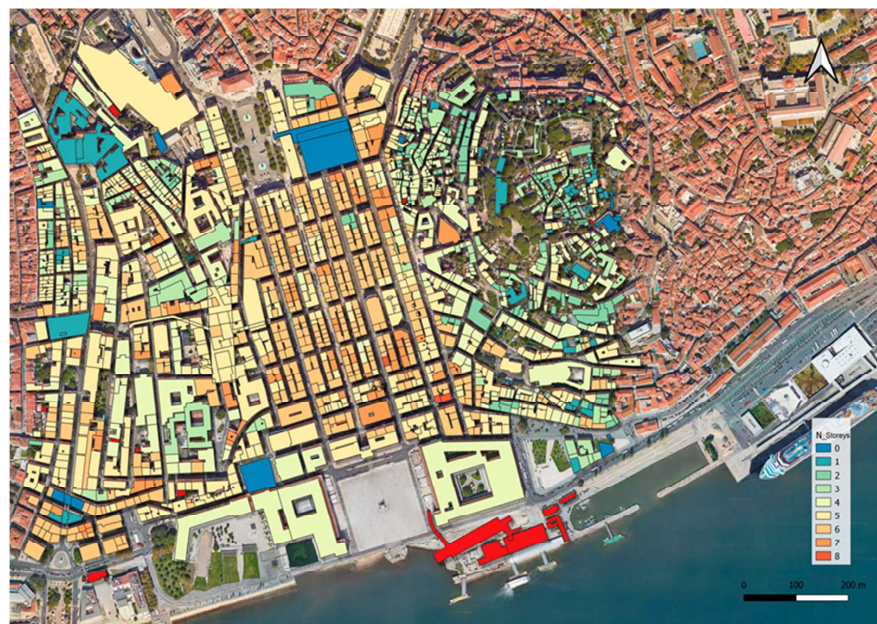
Figure 8. Number of floors for buildings in the historic center of Lisbon (adapted from Camara Municipal de Lisboa).

- data on listed heritage and/or historical-artistic interest;
- archaeological sites;
- museums;
- average floor area;
- the number of stories (Figure 8);
- exposure to the building heritage of the Baixa Pombalina [46];
- the state of conservation (Figure 9).

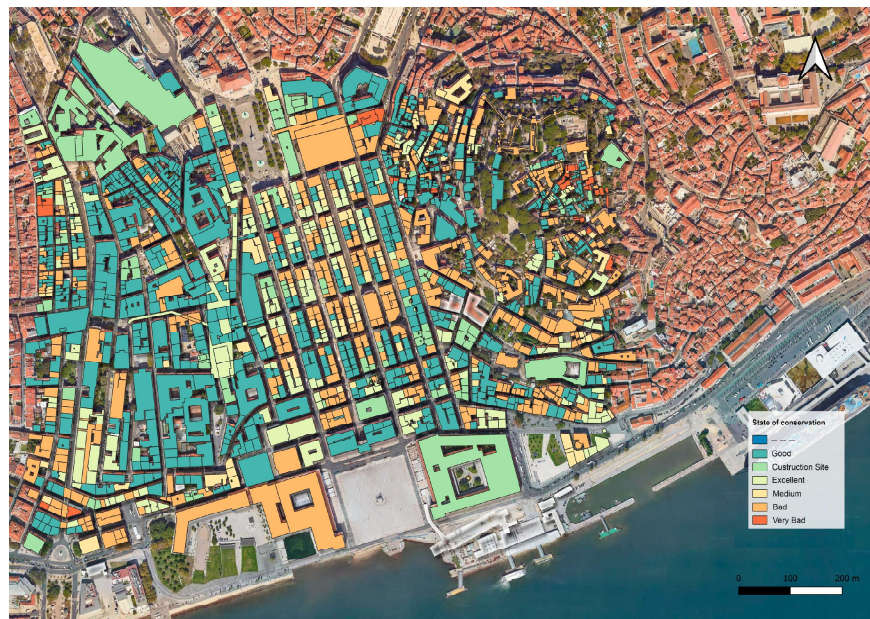
Figure 9. State of conservation of the buildings in the historic center of Lisbon (Camara Municipal de Lisboa, revised through on-site surveys in 2022 by the authors).

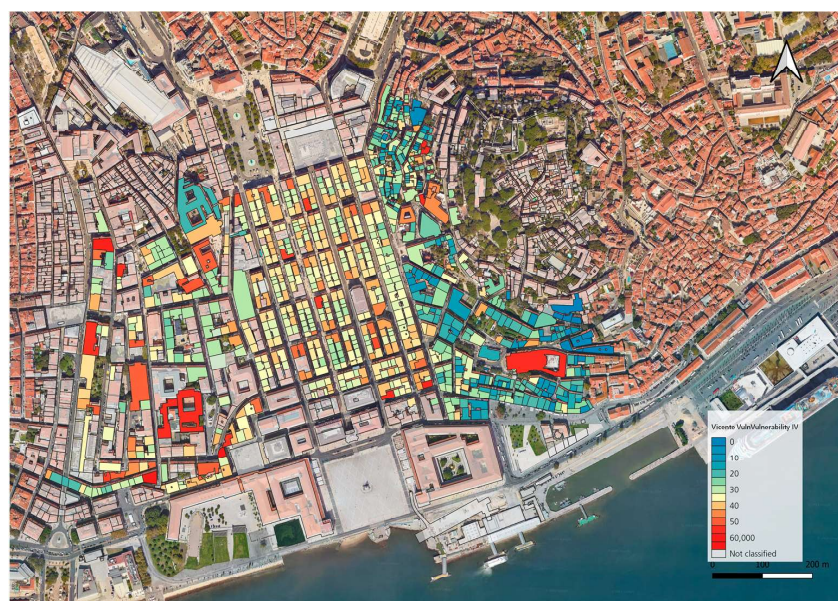
Figure 10. Vulnerability index calculated according to the Vicente method (2011).

From all the information obtained from the research data implemented above, it was possible to obtain all the information necessary to assess the seismic vulnerability of the buildings in the historic center of Lisbon. Two simplified assessments were performed: the first takes up the study done by Catulo [32] on the *Baixa* area, which is based on the Vicente method (2011) based on vulnerability index (VI). Figure 10 shows the mapping of the vulnerability index VI obtained.

From the results obtained from the two vulnerability maps and comparing them with the constructive information collected, it can be seen that the method experimented by Polese et al. is much more severe; however, it does not always reflect the vulnerability that one would expect from a specific construction typology and past vulnerability studies, while the method developed by Vicente et al. turns out to be more consistent. For this reason, the vulnerability index experienced by the latter was used for subsequent analysis.

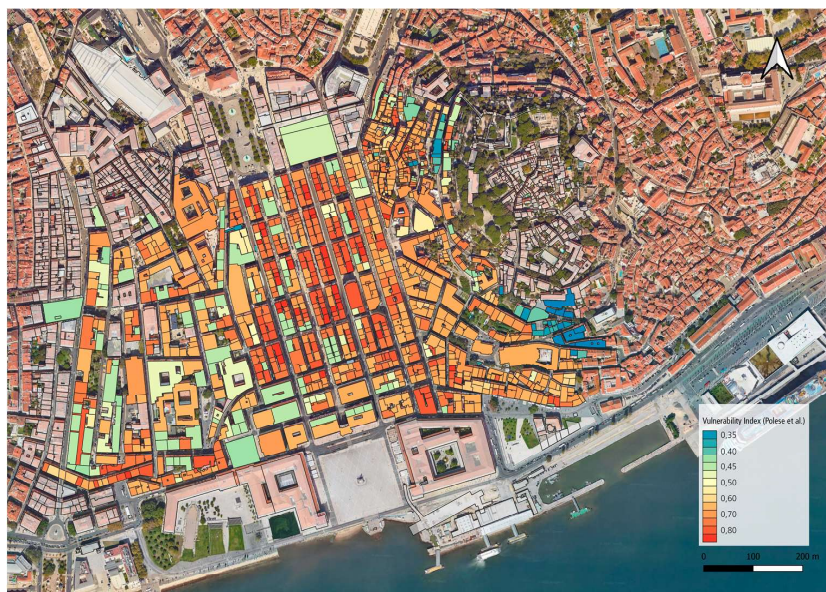
Figure 11. Vulnerability calculated based on the Polese et al. method (2011).

The second method applied for the definition of vulnerability V is the one proposed by Polese et al. [35] (Figure 11), which adapted the method applied by Lagomarsino and Giovinazzi [8] based on the damage probability matrix (DPM). This method needs less data than the previous one.
