QUASI-STATIC INDENTATION BEHAVIOR OF GFRP WITH MILLED GLASS FIBER FILLER MONITORED BY ACOUSTIC EMISSION

Abstract. *This paper aims at investigating the influence of the addition of milled glass fibers upon quasi-static indentation (QSI) properties of glass/epoxy composite laminates. The QSI behavior was experimentally studied by evaluating indentation force, residual dent depth, energy absorbed and size of the damaged area for different indentation depths. Following the QSI tests, the filler-loaded glass/epoxy samples were subjected to three-point bending tests in order to measure residual flexural strength, and the results were compared with the baseline glass/epoxy samples. Both tests were performed with online acoustic emission monitoring in order to observe damage progression and characterize different fracture mechanisms associated with loading. The results show that the filler-loaded laminates exhibit a substantial improvement in the peak force and contact stiffness, with a reduced permanent damage both in terms of depth and of area, in comparison with the baseline ones. It is found that the filler presence offers greater stiffness and higher energy dissipation through tough

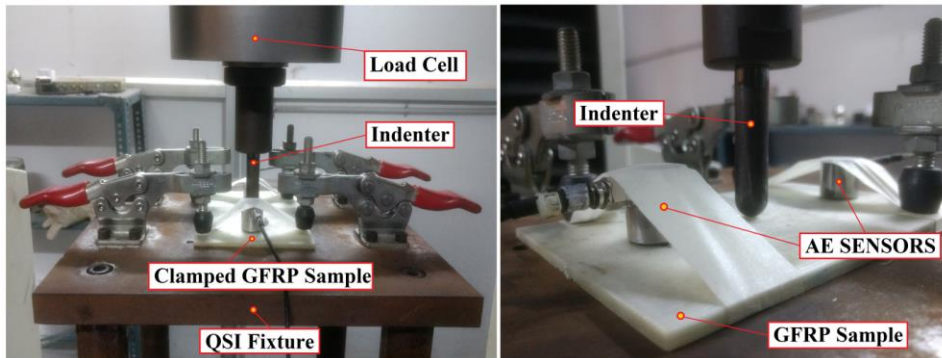
Fig. 1 Quasi-Static Indentation test fixture

Quasi-static indentation tests were performed on the Tinius Olsen 100kN Universal Testing Machine at crosshead speed of 1 mm/min. The test was carried out with the indentation fixture as per ASTM D6264/D6264M-17 standard [30], hence with a hemispherical indenter. The glass/epoxy samples with dimensions of 150 x 100 mm rested on the fixture and were clamped at both sides, as shown in Fig. 1. Later, the indentation test was performed directly on the center of the samples. The specimen was indented with a 12.7 mm diameter hemispherical end steel tup. Load-displacement data were recorded *via* the digital data acquisition system from the universal testing machine. Four specimens were tested in all the cases, and the average results were considered. QSI tests were carried out at a predetermined indentation depth of 1, 2, 3, 4, 5 and 6 mm, respectively. Quasi-static indentation behavior and test parameters, such as indentation force, residual dent depth, energy absorbed, contact stiffness and damaged area at different indentation depths were evaluated. The evolution of damage and damage mechanism associated with indentation were monitored with online AE monitoring.

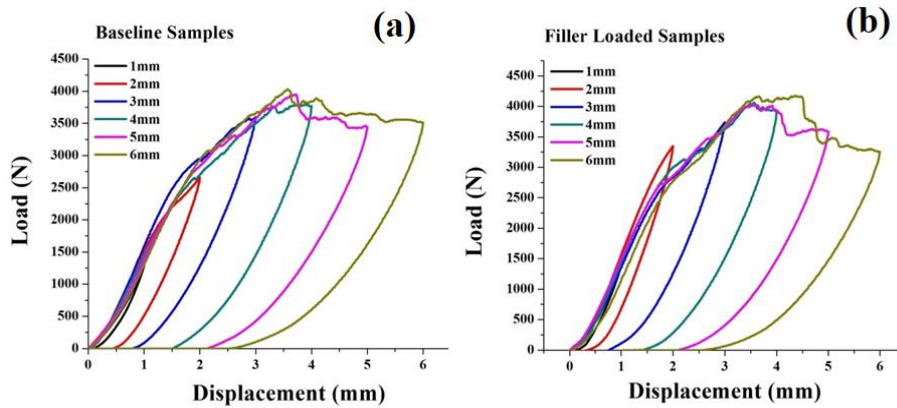
Fig. 2 Load-Displacement curve for different indentation depth: (a) Baseline samples (b) Filler-loaded samples

Figure 2 shows a typical load-displacement curve for the quasi-static indentation test on both baseline and filler-loaded glass/epoxy samples, tested at different indentation depths. The curve profile was initially quasi-linear, which suggested a prevalently elastic behavior: this was followed by the onset of some permanent plastic deformation with increasing indentation displacement. The resistance offered by the samples was observed to increase with indentation depth. Thus, the peak force increases consistently with indentation depth accompanied by a sequence of load drops associated with the occurrence of a significant damage, such as delamination and fiber failure. At a higher indentation depth, the onset of the process leading from fiber disruption to perforation through the appearance of back damage reduces the resistance of the samples through load drops to be ascribed to the indenter producing shear failure and local crushing of fibers during local bending [34]. These load drops are followed by the appearance of a plateau region in the curve, which can be attributed to frictional sliding between the indenter and the sample. In particular, it can be observed that beyond 4 mm no longer any major increase in the peak load is revealed: this was associated with the predominant fiber damage, leading to the appearance of back face damage. Also, the results show that irrespective of indentation depth, the filler-loaded samples exhibited higher load carrying capacity (peak force) than the baseline samples.

The slope of the load-displacement curve during quasi-elastic phase, preceding the first load drop, defines the initial contact stiffness of the glass/epoxy. Further, as the indentation depth increases, non-linear behavior was observed associated with damage accumulation and progression through matrix cracking, while the onset of delamination at a higher delamination depth corresponds to stiffness degradation. More specifically, it was found that the filler-loaded samples exhibit initial contact stiffness of 2181 ± 75 N/mm and delaminated contact stiffness of 955 ± 72 N/mm, against 1902 ± 58 N/mm and 832 ± 75 N/mm for the baseline samples, respectively. In other words, it was observed that the filler-loaded samples exhibited approximately 15% improvement in initial and delaminated contact stiffness, compared to the baseline samples.

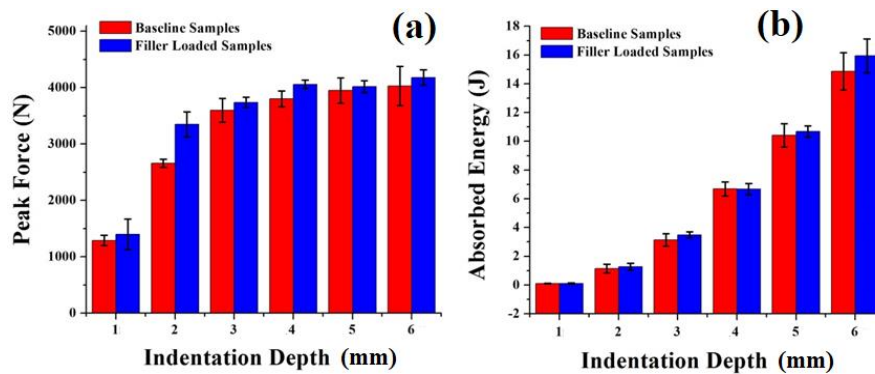
Fig. 3 Comparison of: (a) Peak force (b) Absorbed energy between baseline and filler-loaded samples for different indentation depths

Figures 3 (a) and (b) indicate peak force and absorbed energy variation with respect to indentation depth: both peak force and absorbed energy are slightly higher for the filler-loaded samples; though given the standard deviation, differences are minimal. It can also be observed that while the former shows an abrupt increase at a given indentation depth, particularly between 1 and 2 mm, the latter grows quasi-linearly with it. In general terms, this behavior depends on the fact that the peak force suddenly increases after the contact area overcomes the limit that is related to the dimension of the indenting tip, an evidence which is basically related to its hemispherical geometry [35].

However, at a higher indentation depth, beyond 4 mm, some failure of load-bearing fibers due to induced tensile stress resulted in some reduction in the peak load, which means that the peak loads for both the filler-loaded and the baseline samples were similar. In other words, the influence of the filler on absorbed energy was prominent at a lower indentation depth, while as the indentation depth increases, the contribution of the filler to energy dissipation deteriorates. This was attributed to the damage gradually extending from the matrix to the reinforcement through the intermediate occurrence of some debonding.

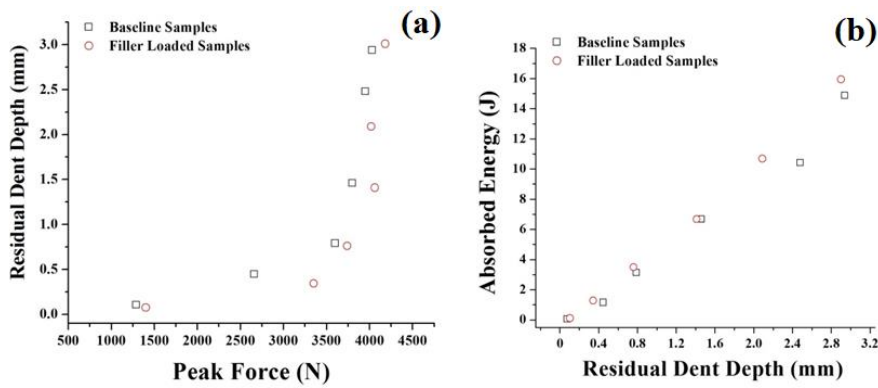
Fig. 4 (a) Peak force vs. Residual dent (b) Absorbed energy vs. Residual dent: comparison between baseline and filler-loaded samples for different indentation depths

What was expected was that the filler-loaded samples would exhibit a reduced damaged area and a smaller residual dent at respective indentation depths in comparison with the baseline ones. The relationship between the peak force and the absorbed energy with a residual (permanent) dent, i.e. the plastic deformation of the samples remaining after unloading for both the baseline and the filler-loaded samples is reported in Fig. 4. In general, both the absorbed energy and the residual dent are increasing with the indentation force. The relation between the peak force and the residual dent indicates that the accumulation of damage is dependent on indentation displacement. The change in the slope was observed to be small/gradual at a lower indentation depth below 3 mm corresponding to matrix cracking and some delamination damage. As the indentation depth increases, the slope of the curve changes rapidly while the peak force remains almost unchanged. The occurrence of fiber breakage with matrix cracking and delamination contributes to an increase in the residual dent depth and with no raise in the peak force, suggesting at this point the transition of failure mechanism from gradual to severe, substantially indicating the occurrence of fiber failure, basically signifying that no resistance is offered by the broken fibers. It is observed that the filler-loaded samples exhibit a lower permanent depth

by an average of 25% than the baseline samples. The filler presence offers improved stiffness and also higher energy dissipation through plastic deformation.

Figure 4 (b) shows the relationship between the permanent dent depth and the absorbed energy for the baseline and the filler-loaded samples. It is well known that the energy absorbed by the samples is utilized for investigating damage development. Thus, the responses of the absorbed energy and the residual dent are dependent and the results show that the trend of the absorbed energy and the residual dent was almost linear till an indentation depth below 4 mm. However, as the indentation depth increases further, the damage is close to saturation in the laminate, which causes marked non-linear behavior. Irrespective of indentation depth, the residual dent depth induced on the filler-loaded samples was consistent and depended upon the absorbed energy, which, in its turn, was higher with the reduced residual dent comparing to the baseline samples. It was observed that the fillers presence enhanced the energy dissipation capacity of the laminates, which was attributed to the toughening mechanism, such as filler debonding/pullout, filler interlocking/bridging of cracks, as will be seen in Fig. 12.

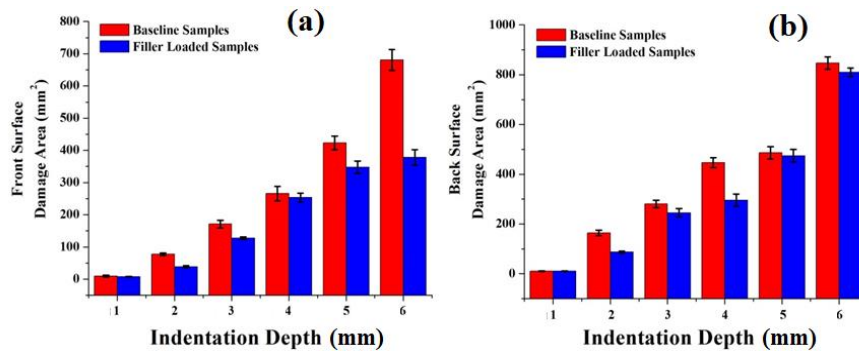
Fig. 5 Damage area at different indentation depth for baseline and filler-loaded samples: (a) Front surface (b) Back Surface

More indications were expected to come from the measurement of the extent of the damaged, hence delaminated, areas, by non-destructive backlight imaging of the damaged samples with ImageJ software for post-processing: these are reported in Fig. 5 for various indentation depths. The delaminated area had irregular shape and perimeter, despite being centered on the point of indentation. The damage area at the back surface was observed to be greater comparing to the front surface, suggesting a larger disruption if the fiber layers with indenter progress in the laminate, significant for the reduction of flexural performance [36]. The damage area was found to be reduced in the filler-loaded samples for an average of 25% less than for the baseline samples. This is due to the higher rigidity/stiffness offered by the filler-loaded samples resulting in energy dissipation through toughening mechanism such as filler debonding/pullout, filler bridging/interlocking, as will be seen in SEM images. This proves that the filler inclusion resulted in higher energy absorption with a reduced damage area, contributing to enhanced crashworthiness properties of the laminates.

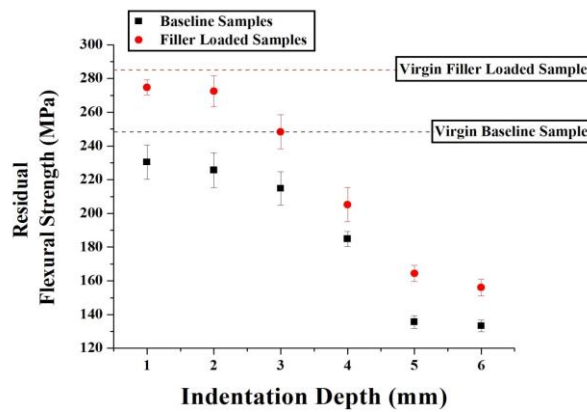
Fig. 6 Residual flexural strength for baseline and filler-loaded samples at different indentation depths

In particular, the effect of the filler introduction on the residual flexural strength after indentation allowed observing that the filler-loaded samples exhibited an average of 18% higher load carrying capacity than the baseline samples (Fig. 6). In particular, three-point bending strength of non-indented laminates was 249 ± 6.5 MPa for baseline ones and 284.5 ± 8.3 MPa for filler-loaded ones. Bending effects are the cause of shear forces leading to delamination propagation toward a free edge during the three-point bending test. This propagation expands from the former delamination damage developed during quasi-static indentation, followed by a newly generated damage. The damage evolution was observed to be gradual on the samples subjected to a low indentation depth showing matrix cracking, and debonding damage followed up by the ultimate failure by fiber breakage at compression or tension side of the samples. The residual flexural strength was observed to reduce gradually by an average of 15% for an indentation depth above 3 mm. In addition, the samples subjected to higher indentation exhibit penetration/perforation damage leading to a large delamination area and intensive fiber breakage.

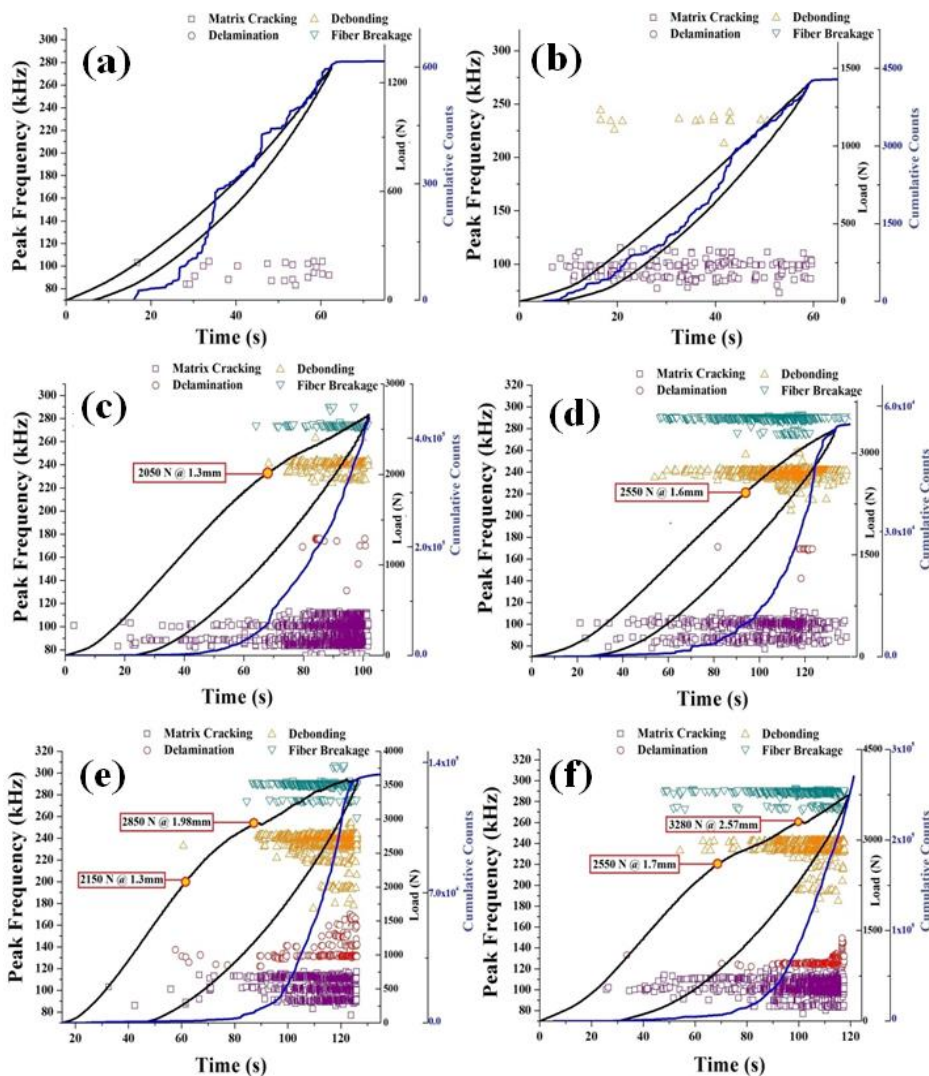
Fig. 7 Peak frequency & Cumulative Counts vs. Time plot of corresponding load-displacement behavior for indentation depth. Baseline samples: (a) 1mm (c) 2mm (e) 3mm & Filler-loaded samples: (b) 1mm (d) 2mm (f) 3mm

In particular, Figs. 7 (a) and (b) show the results for a lower indentation depth of 1 mm. Both in the baseline and the filler-loaded laminates, the damage initiates in the form of matrix cracking, while fiber/matrix debonding was observed only in the case of the filler-loaded samples; delamination was not yet evident at this indentation depth. This can suggest that the filler-loaded laminates may provide higher energy dissipation through an additional toughening mechanism such as filler/matrix debonding offered by the presence of milled glass fibers. In practical terms, at 1 mm indentation depth, no significant damage was visible in both the baseline and the filler-loaded samples, except minor local indentation at the contact of the indenter. This will be confirmed in Fig. 9, with no delamination/debonding visible for 1 mm indentation depth in the baseline samples.

Figures 7(c) and (d) show the results for an indentation depth of 2 mm, where the damage onset load (or) delamination threshold load was indicated from the incipient point during quasi-static indentation. Typically, the incipient point defines the initial change in the slope or a drop in the load where delamination occurs during testing. The baseline samples

show a change in the slope during 2050N and 1.3mm indentation depth, while the filler-loaded samples indicate a change in the slope only during 2550N and 1.6mm indentation depth. Correspondingly to this load/indentation, damage accumulation was observed attributed to a sudden and abrupt increase in the AE cumulative counts with a change in the slope associated with a major failure, such as debonding/delamination, as observable from the peak frequency-time plot. These failure modes were nominal at 2 mm indentation depth and consequently exhibit a smaller damage area, as seen in Fig. 9. The size of the damaged area, the intensity of damage and relevant damage mechanism were observed to increase with indentation depth.

The indentation response of the glass/epoxy samples subjected to 3 mm indentation depth can be seen in Figs. 7(e) and (f). In this case, the change of the slope of the load-displacement curve indicates reduced contact stiffness of the material due to the initiation of damage mechanisms, such as matrix cracking, debonding and delamination, as can be seen in Figs. 10 and 11. As previously discussed, the flat region of the curve of the AE cumulative counts indicates the damage initiation stage attributed to low-frequency failure mode matrix cracking, whereas the initiation of delamination in the baseline samples occurred at 2150N and 1.3mm, followed by a sudden load drop at 2850N and 1.98mm, corresponding to the fiber failure, as seen in Figs. 10 and 11.

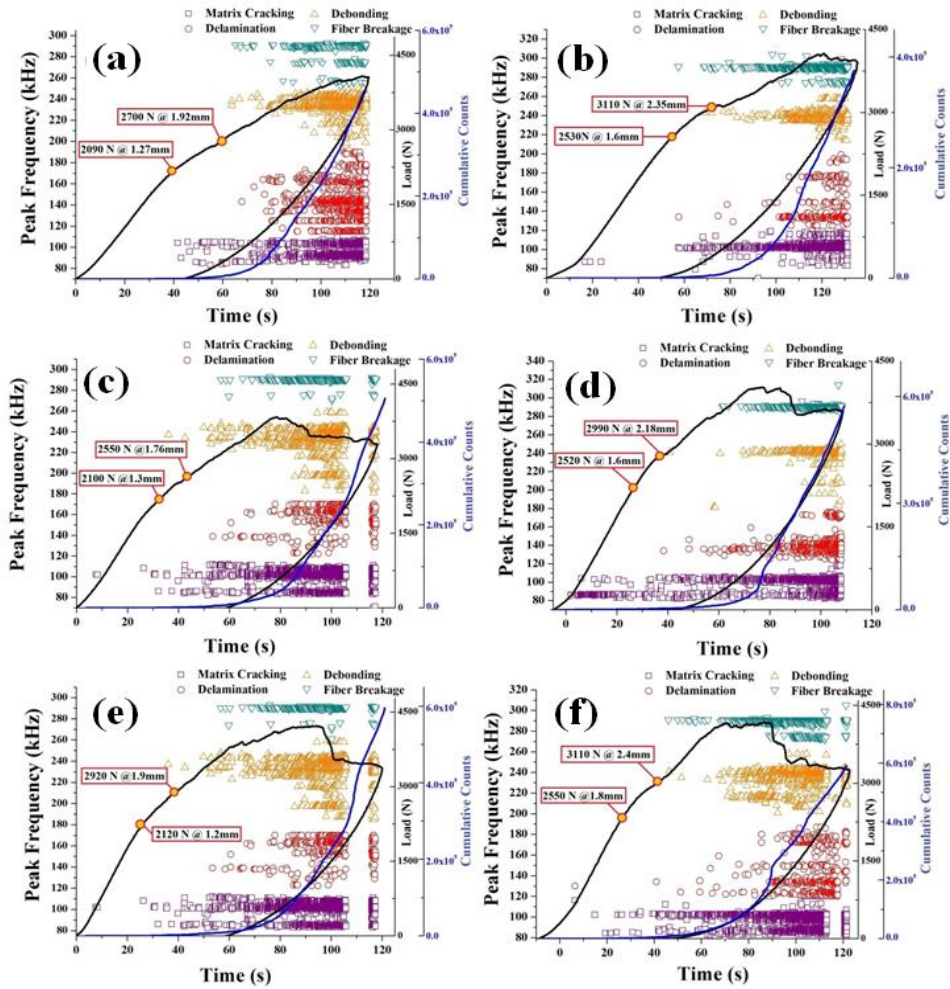
Fig. 8 Peak frequency & Cumulative Counts vs. Time plot of corresponding load-displacement behavior for indentation depth. Baseline samples: (a) 4mm (c) 5mm (e) 6mm & Filler-loaded Samples: (b) 4mm (d) 5mm (f) 6mm

Figures 8 (a) to (f) show the load-displacement behavior of the baseline and the filler-loaded samples indented at 4, 5 and 6mm. The same trend was observed with a flat profile of the AE cumulative counts indicating the damage initiation stage and a steep rise in the slope of the curve showing the damage accumulation. It was observed that the damage onset load in the baseline samples occurred at an average of 2100 N at 1.2mm followed by a sudden load drop at 2700N and 1.8mm corresponding to the fiber failure. In contrast, the filler-loaded samples exhibited delamination damage load and a load drop related to fiber damage at 2500N and 1.6mm, and 3100N and 2.1mm, respectively. It is significant to observe that the damage onset load and the fiber breakage load exhibited by the filler-loaded samples were for about 20% and 15% higher than the baseline samples, respectively. This is due to enhanced energy dissipation through toughening mechanism such as filler/matrix debonding, filler interlocking/bridging which contributes to higher load-bearing capacity.

At a higher indentation depth, a fiber failure occurs during penetration/perforation of the samples which reduces the load resistance capability. Beyond 4 mm indentation depth, all the samples show the same trend in peak load and absorbed energy, while no significant increase was observed due to a more intense fiber failure. The failure occurred through matrix shear cracking, and fiber micro-buckling at the local contact of the indenter, followed by delamination between the adjacent plies and intra-laminar cracking (or) axial fiber splitting through penetration/perforation of the indenter. It is clearly seen that the

delamination onset load was almost similar for all the samples while the improvement in the fiber breakage load reduces drastically with an increasing indentation depth due to the perforation/penetration of the samples.

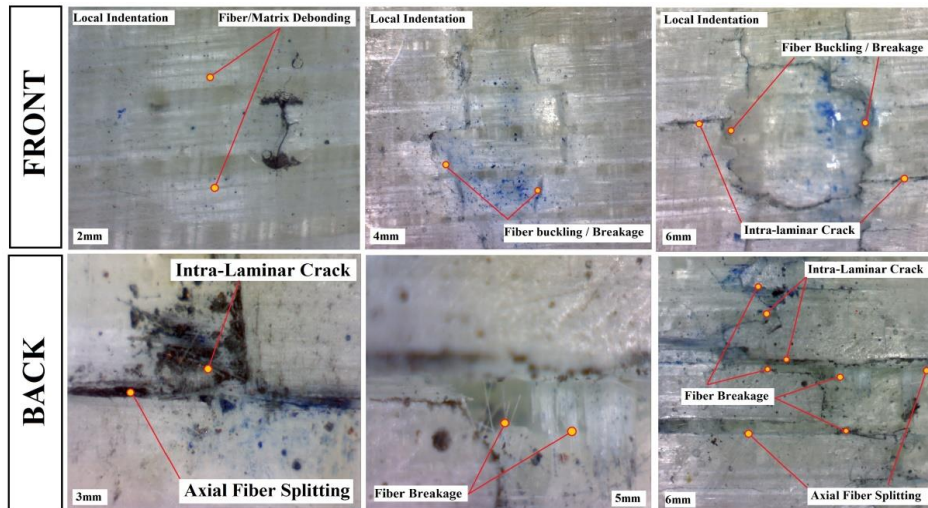
Fig. 10 Optical microscopic images of the fractured surfaces observed during quasi-static indentation test for baseline samples

Figures 10 and 11 show optical microscope images of the fractured surfaces observed during the quasi-static indentation test in the baseline and the filler-loaded samples. At a lower indentation depth, matrix fracture damage occurs, which decreases the localized stiffness of the laminate, but does not result in any catastrophic failure. However, further increasing the indentation displacement can cause the matrix cracking to progress into delamination and fiber breakage, due to the tensile stress caused by the indenter contact. In general, the transverse matrix cracking develops into delamination between the adjacent plies, and finally, prevalent intra-laminar crack and in-plane fiber buckling/breakage cause penetration and perforation damage at a higher indentation depth (4 to 6 mm). Figures 9, 10 and 11 show that the intensity of damage in the baseline samples was predominant comparing to the filler-loaded samples, especially at a higher indentation depth.

In contrast, the damage exhibited by the filler-loaded samples was minor and delayed, due to the improved load carrying capacity and energy absorption characteristics offered by the presence of fillers. Figures 12 (a) and (b) show scanning electron microscope images of the fractured surfaces of the baseline and the filler-loaded samples. The baseline samples

exhibit smooth and brittle fracture surface associated with no plastic deformation corresponding to low fracture toughness of epoxy matrix. However, the fracture surface of the filler-loaded samples indicates rough surface with intense scarps/river lines. The intense scarps/river lines indicate hindrance of crack growth. Figure 12 (b) shows the fillers strongly bonded to the matrix and filler debonding/pullout, which can be attributed to the additional energy dissipation mechanisms.

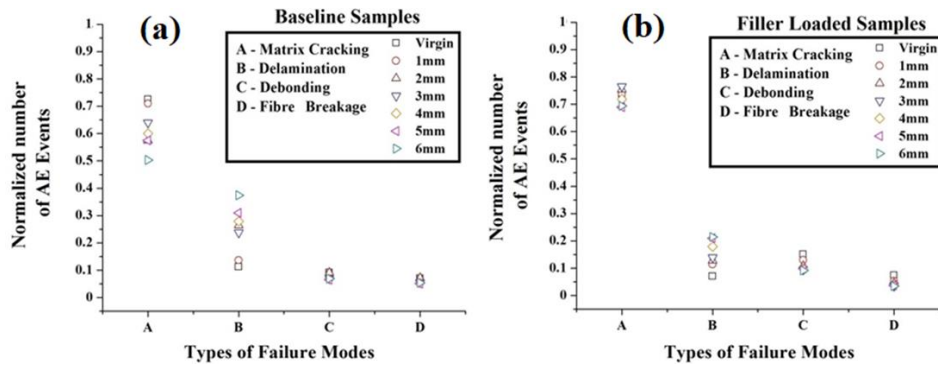
Fig. 13 Types of failure modes versus normalized number of AE events for Flexural After Indentation test: (a) Baseline Samples (b) Filler-loaded Samples

Figure 13 shows the normalized number of AE events exhibited during flexural after indentation test associated with types of failure modes for baseline and filler-loaded samples. The damage mechanisms associated with flexural after indentation test were characterized from frequency ranges, as discussed above. It can be observed that the delamination signals intensity in the baseline samples are more intense and greater than the filler-loaded samples which validate the correlation between these data and those of the damage areas. It can be observed that the matrix cracking signals associated during the test were found to be concentrated and more intense since they start almost from the beginning of loading; this triggers the other failure modes in both the baseline and filler-loaded samples. The number of the AE events associated with the delamination signals for the baseline samples was found to be more intense comparing to the filler-loaded samples: this trend was observed to be prominent at a higher indentation depth (beyond 4 mm). It can be suggested that, at this point, quasi-static indentation on the glass/epoxy samples has caused sufficient delamination damage, which might progress during post-indentation flexural testing. Correspondingly, the number of the AE signals attributed to matrix cracking decreases, while those related to delamination increase for the samples indented beyond 4 mm. This evidences that during flexural loading, the damage initiates as matrix cracking in the non-indented samples and samples indented below 4 mm. In contrast, in the samples indented beyond 4 mm, the failure starts/develops from the former damage mode (usually delamination / debonding). Consequently, the debonding and fiber breakage signals observed in all other cases were almost similar, and no significant changes in the intensity of AE signals were observed as seen in Fig. 13(a).

Similarly, Fig. 13 (b) shows the normalized number of the AE events with corresponding types of failure modes exhibited by the filler-loaded samples during flexural after indentation test. It can be observed that the normalized number of the AE events corresponding to the matrix cracking was highly predominant for the filler-loaded samples in all the cases (virgin and all indented samples). In contrast, the number of the AE events corresponding to delamination signals was observed to be lower for the filler-loaded samples than the baseline samples, even for the samples subjected to a higher indentation depth. However, the corresponding debonding signals associated with the test in the filler-loaded samples were greater than the baseline samples. This is due to the filler presence in the interlaminar domain introducing toughening mechanism, such as filler debonding/pullout resulting in more intense debonding AE events. Subsequently, the number of the AE events related to the fiber breakage was almost similar in both the baseline and the filler-loaded samples for all the cases of flexural after indentation.
