Failure analysis of fiberglass cover used for photovoltaic plants

Abstract

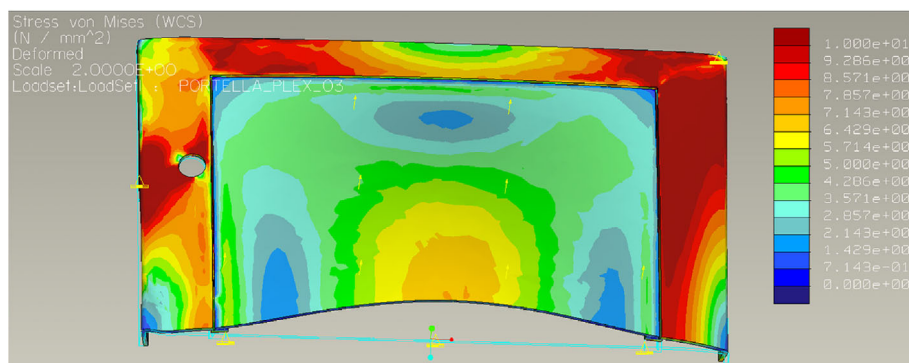
FIGURE 7 Box stress due to air expansion. [Color figure can be viewed at wileyonlinelibrary.com]

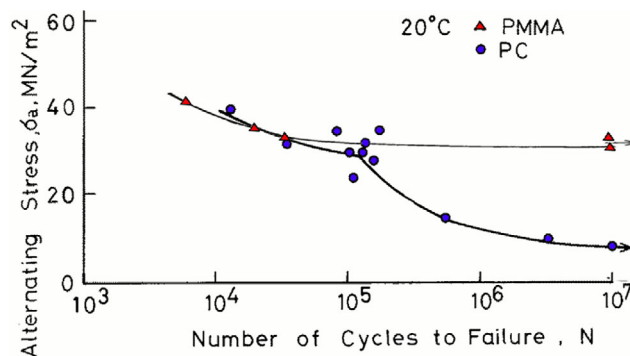
FIGURE 8 The stress of PMMA versus PC (polycarbonate) due to cyclic loads. [Color figure can be viewed at wileyonlinelibrary.com]

box, which are reflected in the expansion of the material and on the air pressure, are applied with a cyclic frequency. In the case of PMMA cyclic loads,³⁶ a specific maximum admissible stress needs to be considered (Figure 8).

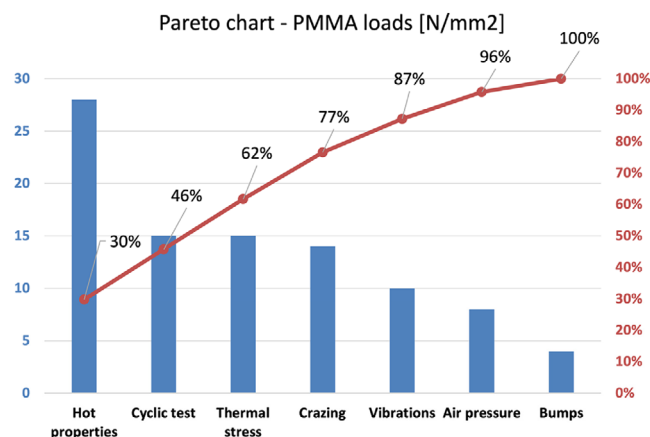
FIGURE 10 Relevance of the loads affecting the PMMA. [Color figure can be viewed at wileyonlinelibrary.com]

analyzed before can be simultaneously present. One or more of the loads analyzed in the previous paragraphs can be present at the same time. Table 2 summarizes the mechanical properties of PMMA and the loads to which it can be subjected. The percentage incidence of each phenomenon is shown in Figure 10.

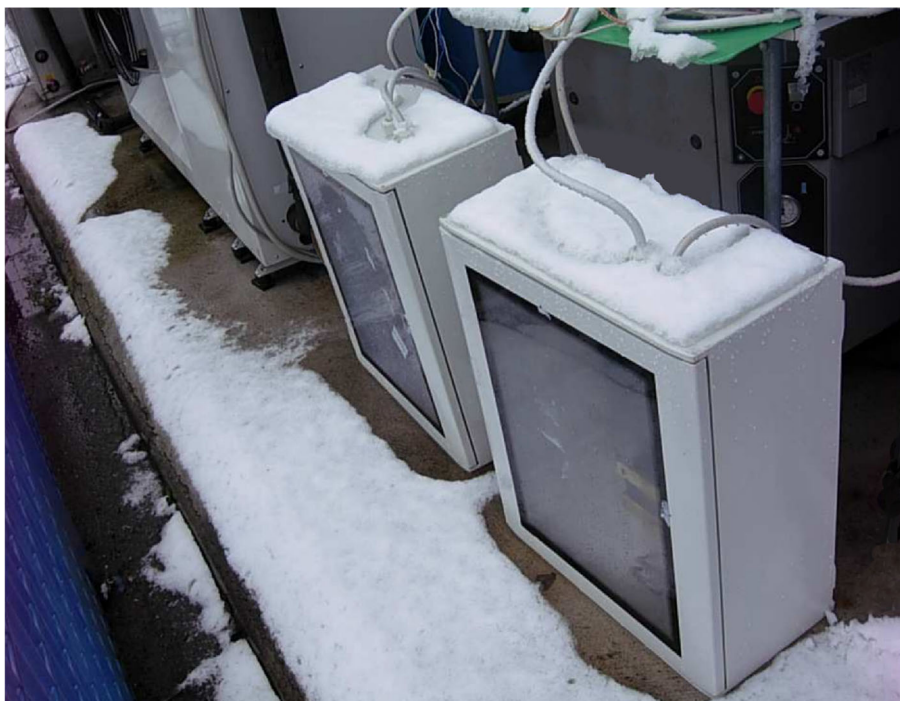
FIGURE 12 Cycle 4, outdoor settling time. [Color figure can be viewed at wileyonlinelibrary.com]

The settling time of the cycle 4 lasted 21 days (Figure 12); during this phase, cracks slowly began to appear on the edge of the PMMA window (Figure 13).

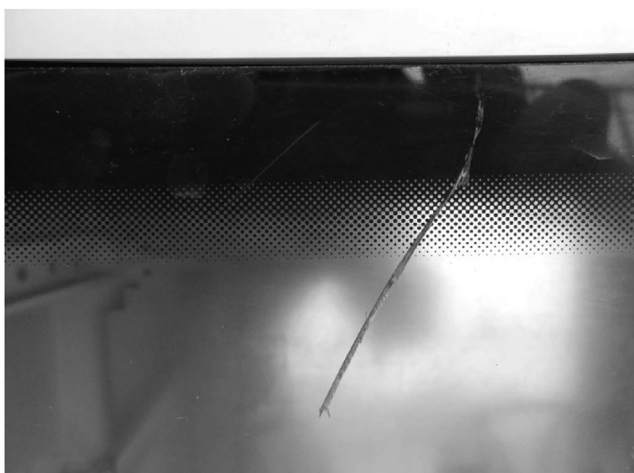
FIGURE 13 Crack propagation.

The cracks have spread until they intersect each other. At the end of the tests the PMMA window broke into 4 parts while the polycarbonate porthole was intact.

This environmental crazing investigation pushes us to examine polymer "glass" thermoplastic blends further. Selecting a polymer matrix material that is more compatible with SMC support may be advisable. According to preliminary findings, PC is far more resistant to this crazing effect than PMMA. Replacing PMMA with PC has eliminated the problem of cracks in this application.
